Disturbance Measurements from Off-Road Vehicles on Seasonal Terrain

Final report

ERDC/CRREL TR-05-12

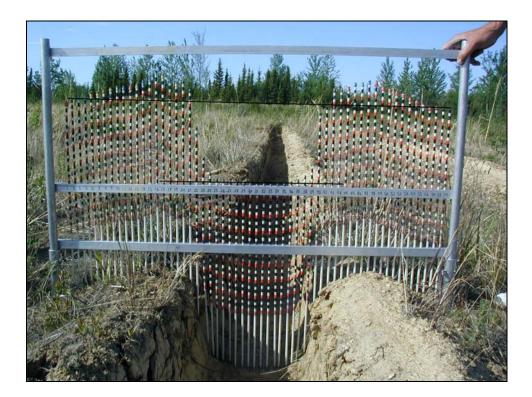
Figure 3. Rut depth measurement and determination using a profilometer.

Rut depth is the distance measured between the bottom of the tire track that has been caused by vehicle traffic and the adjacent undisturbed soil surface. Rut depth is typically measured with a profilometer, which is placed in the center of the tracks, and depths. This was the technique used at Fort McCoy and DTA. However, more detailed rut depth data were collected from the maneuver impact tests at DTA using a profilometer made of a metal bar with sliding rods as shown in Figure 3. The rods are spaced every 2 cm horizontally and each rod is marked at 1-cm intervals vertically. The profilometer was placed in the center of the rut and a photo of the rut depth taken, and its location noted using a GPS unit. The photos were printed and lines were drawn of the natural (undisturbed) ground surface profile (the outside of the ruts) and maximum level of the rut. Rut depth is determined by counting the 1-cm intervals on the rod between the surface and rut lines (Fig. 3).

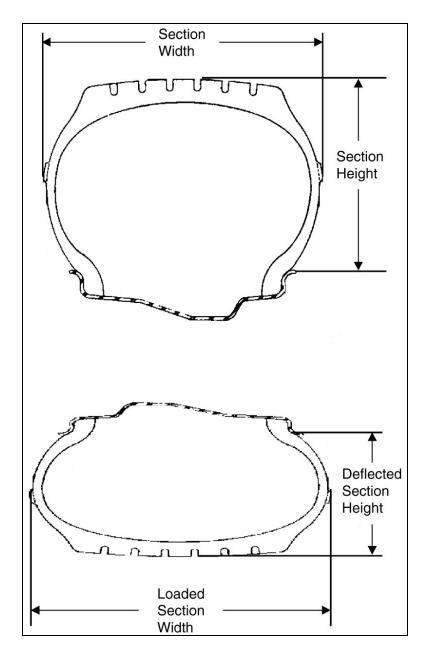
Figure 4. Measurement of tire dimensions.

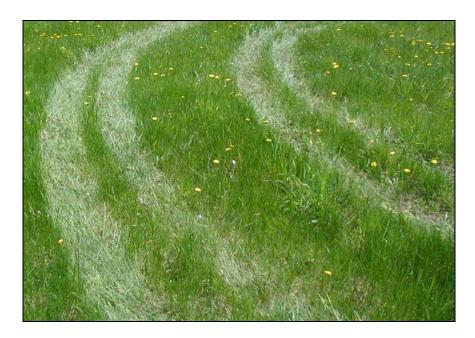
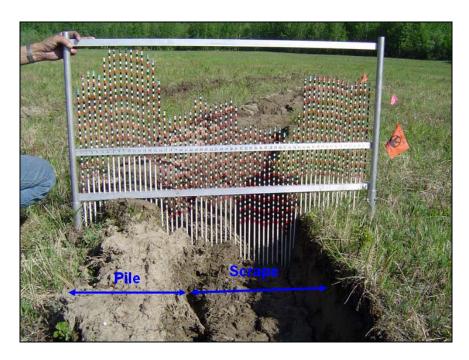
a. Example of imprint disturbance.

b. Example of a combination of pile and scrape disturbances.

Figure 6. Disturbance categories used to determine impact severity.

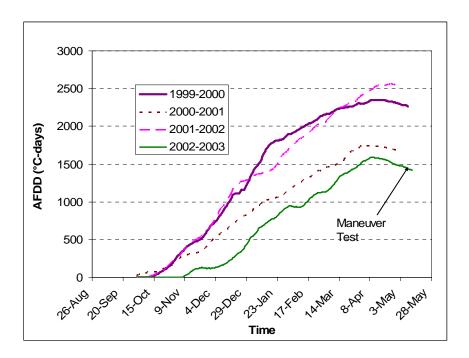
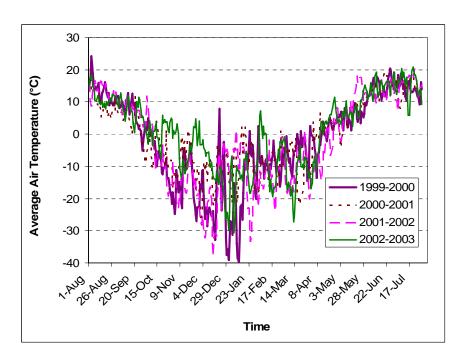
a. Air freezing degree days chart.

Figure 7. Air freezing degree days and daily average temperatures for Delta Junction, Alaska, for four winter seasons.

b. Daily average temperatures.

Frost penetration calculations using the Stefan and modified Berggren equations for each site are given in Appendix B, based on the air freezing index and annual mean temperature prior to spring breakup. Frost depth results do not account for permafrost depth and conditions, especially at the Texas Range site. Observations of ground temperature measured for Big Delta, Alaska, were reported by Aitken (1964). It was noted in Aitken's report that the average measured seasonal frost penetration of the area from the temperature profile was approximately 4.3 m (14 ft), and the mean annual snowfall was 93.7 cm (36.9 in.). The mean annual air temperature ranges from 0.8 to –1.9 °C based on 1999–2003 temperature data.

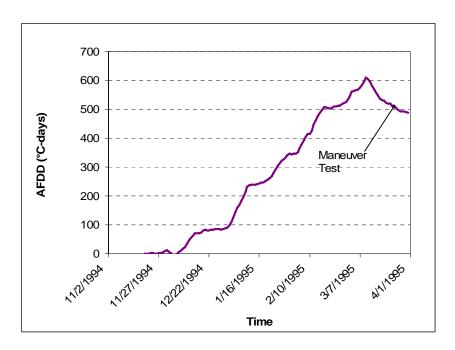
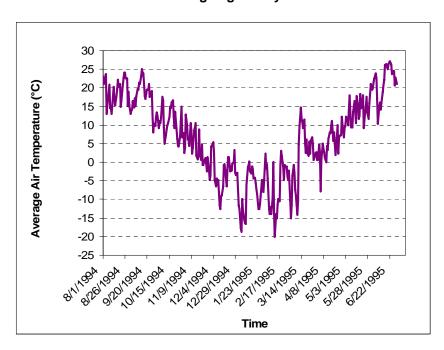
Figure 8. Graph of air freezing degree days and daily average temperature for Sparta, Wisconsin, for the 1994–1995 winter season.

The average freezing season for the area is 117 days, with a freezing index of 608 °C-days for the winter season of 1994–1995 (Fig. 8). The area's mean annual air temperature is 6.8 °C. The expected frost depth of this site based on modified Berggren equations was 0.7 m (2.3 ft) for the 1994–1995 winter season (Table B1).

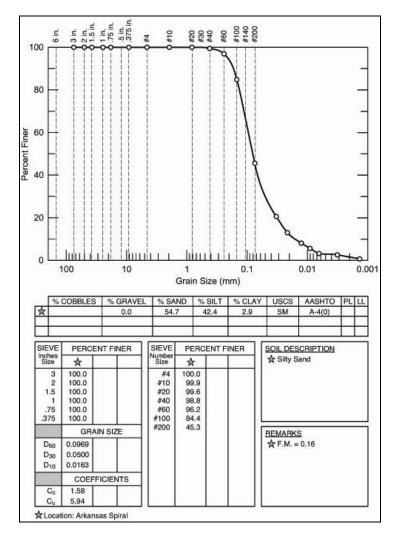
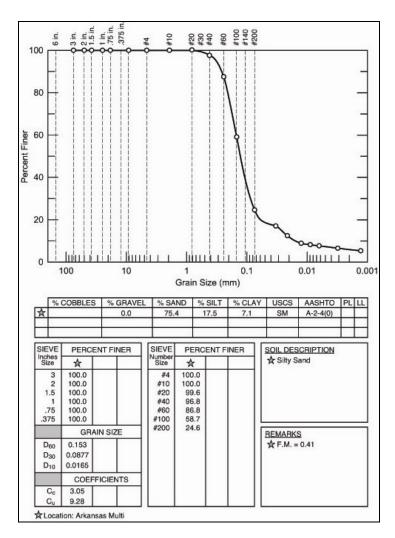
a. Spiral test section.

Figure 9. Grain size distribution of the soil at the spiral and multi-pass test sections at Arkansas Range.

b. Multi-pass test section. Figure 9 (cont'd).

<u>Arkansas Range</u>. The terrain is characterized as a fairly flat and non-permafrost terrain. The soil is outwash deposit, and the gradation curves of the material are classified under USCS as silty sand (SM) (Fig. 9). The silty sand material has a zero plasticity index with decomposed organics on the top 2 cm of the surface.

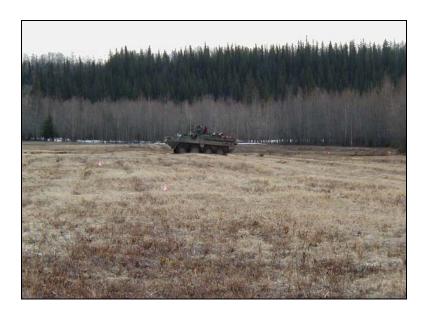
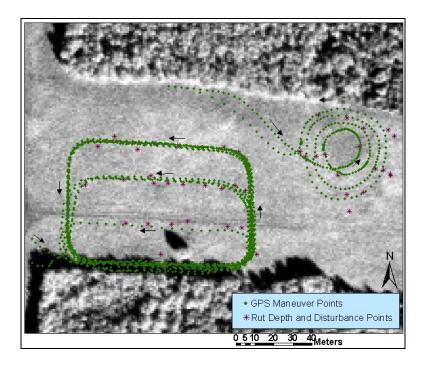
a. Vegetation features.

b. Pattern of maneuver impact test.

The vegetation is composed of grass and short bushes, and was previously mowed in the fall (Fig. 10a). Figure 10b is a map of the GPS tracks, showing the maneuver pattern overlying the ortho-photo. The thirteen-pass test section was located near the tree line, as seen on a map of the maneuver pattern (Fig. 10b). Big roots from the trees were visible on the surface in some areas. The spiral section and the easternmost portion of the multi-pass area were very wet, with surface water ponding; however, the rest of the multi-pass section was fairly dry.

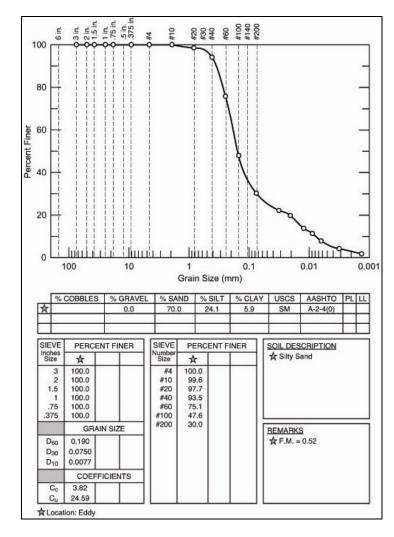
Figure 11. Gradation curve of the soil at Eddy Drop Zone.

Eddy Drop Zone. This site was located on fairly flat, non-permafrost terrain. The soil is glacial outwash deposit and is classified as silty sand (SM) according to USCS. Figure 11 shows the grain size analysis of the soil at the site with zero liquid and plastic limits (non-plastic material). An organic layer ranging from 5 to 10 cm (2 to 5 in.) overlays the soil.

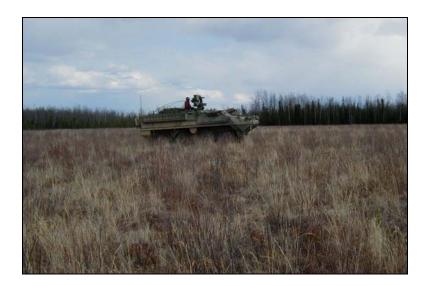
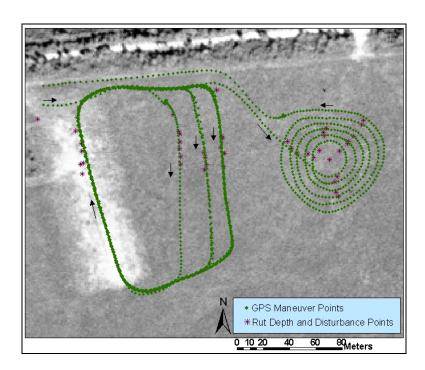
a. Vegetation features.

b. Pattern of maneuver impact test.

The vegetation is composed of sphagnum moss, sedge, tall grass, and thick bushes up to 1 m (3.5 ft) tall (Fig. 12a). A GIS map with the GPS points tracks maneuver pattern for the multi-pass and spiral test sections is shown over the ortho-photo in Figure 12b. (The vegetation appears as a darker gray on the map.)

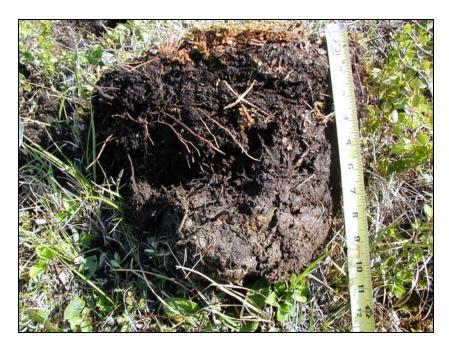
Figure 13. Highly organic material located at the Texas Range maneuver site.

<u>Texas Range</u>. This site is an alpine tundra area with an ecological land classification of lowland tussock scrub bog on gently sloping permafrost terrain. The active layer was mostly frozen during the maneuver tests. The soil is described as glacial loess and moraine deposits with very high organics content. The material is characterized as peat as shown in Figure 13.

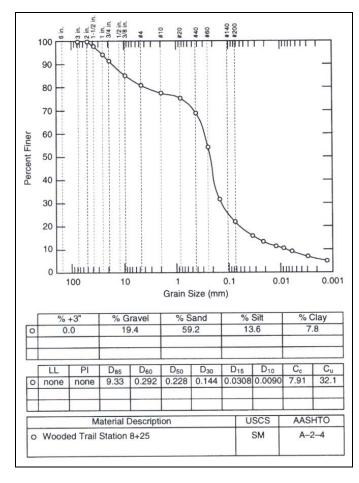
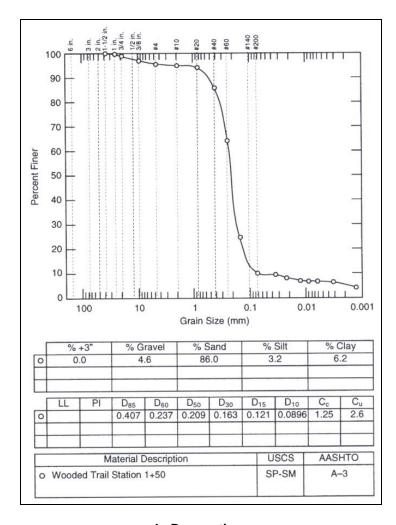
a. Wet section.

Figure 15. Gradation curves for soils on control sections of wooded trail at Fort McCoy. (After Kestler et al. 1999.)

b. Dry section.

The trail consisted of a 0- to 10-cm (0- to 4-in.) vegetative/organic mat on top of a sandy soil. The particle size distribution curves of the two control sections are shown in Figure 15. The soils are classified as silty sand (SM) and poorly graded sand with silt (SP-SM) on wet and on dry test sections, respectively. Both of these soils have a zero plasticity index. The frost susceptibility classification of the soil varies from a very low to a very high frost-susceptible range, classified as F2 on Table 2-7 by Andersland and Ladanyi (1994). The terrain is relatively flat with a slope ranging from a 0.6 to 2.8% grade (Fig. 16). The groundwater table was close to the surface. The average gravimeter water contents on the two control sections used in this report are 15% and 22%.

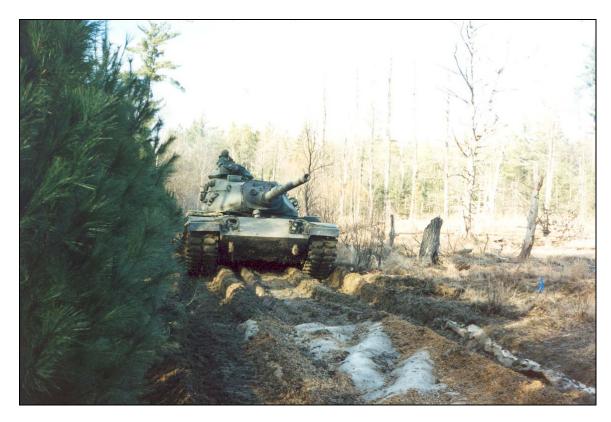
Figure 16. Control section of the wooded trail at Fort McCoy trafficked by an M60A3 in April 1995.

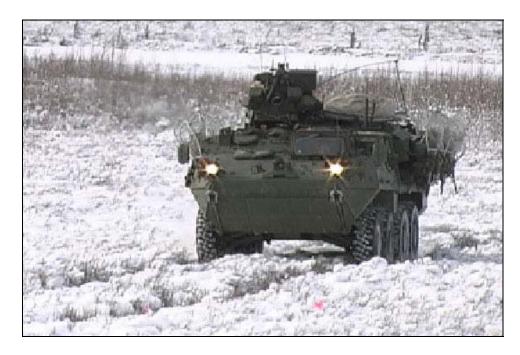
Figure 17. Stryker disturbance test in March 2003 at the Texas Range.

A disturbance test was conducted using the Stryker vehicle in March 2003 as shown in Figure 17. Both multi-pass and spiral tests were performed. The test was located on the southwest area of the spiral section in May at the Texas Range shown in Figure 14. Snow depth during the test was very shallow, approximately 10 cm (4 in.). Snow density was not recorded. The site had no snow cover in February and the winter was considerably mild for the area, as noted in Section 4.2.1. The ground was observed to be frozen. As stated in Section 4.3, the terrain at the Texas Range is on permafrost. However, the depth of permafrost was not determined for this test. The active layer is assumed to be frozen all the way to the permafrost.

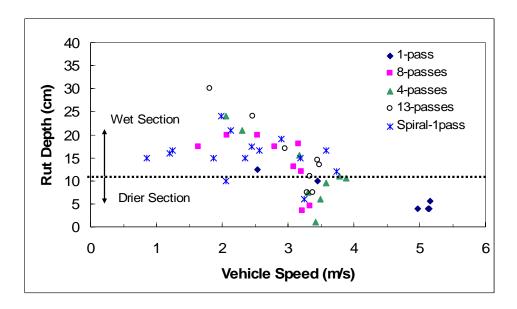
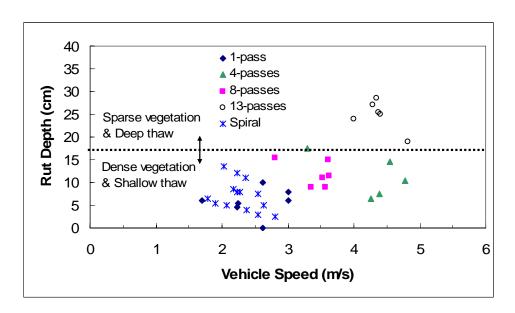
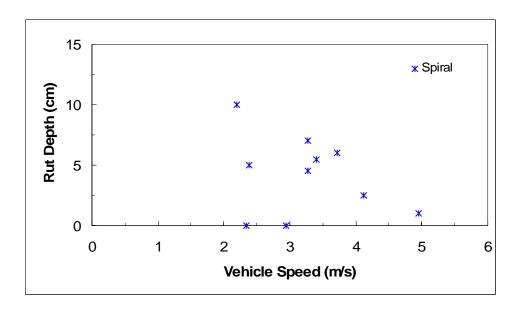
Figure 18. Stryker vehicle average speed from a GPS unit at locations where rut depth data were measured at Arkansas Range, Eddy Drop Zone, and Texas Range.

The speeds along the spiral section at Texas Range were variable (Fig. 18c). This test section had very shallow thaw depths, ranging from 7.6 to 10 cm (3–4 in.); thus, the rutting disturbance to vegetation was minimal in comparison (Fig. 18c). The disturbance was mostly exhibited as imprints from the tire track, where the vegetation was compressed to the ground with minimal shear or vegetation removal and bare ground. The soil samples that were taken at this site contained ice lenses, and the moisture content was up to 356.7%.

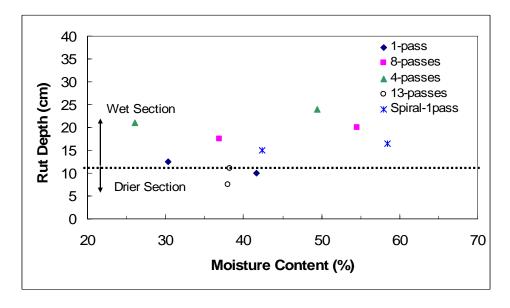
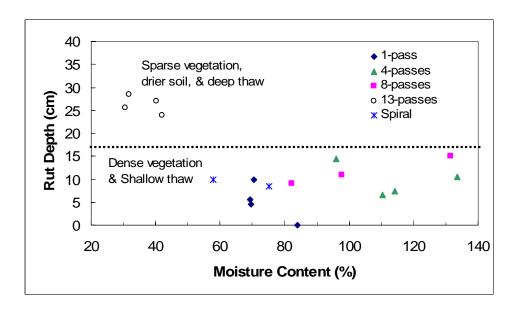
Figure 19. Gravimeter water content versus rut depth at Arkansas Range and Eddy Drop Zone.

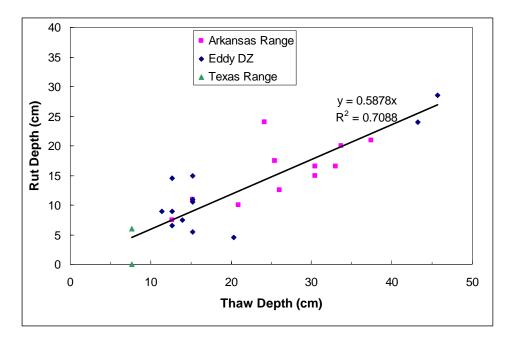
Figure 20. Relationship between average rut depth and thaw depth for all three sites at DTA.

The typical rut profile of deep ruts on the straight sections at the Arkansas Range and Eddy Drop Zone comprised a symmetrical deformation showing exposed soil in the center of the tire track, with steep sidewall and capped lip of displaced soil and vegetation raised 10 cm or more above the adjacent uncompacted soil. Ruts on turns often exhibited one lip (outer side) higher, with a bigger quantity of displaced soil and vegetation next to the adjacent undisturbed soil, than the other lip. The profile of the shallow ruts, such as in the case at the Texas Range and spiral section at the Eddy Drop Zone, with deeper organic layer and dense vegetation, was mainly compression to the thawed layer with a small sidewall and often no distinct lip. Selected photos of rut profiles at each site at DTA are shown in Figures A1–A9.

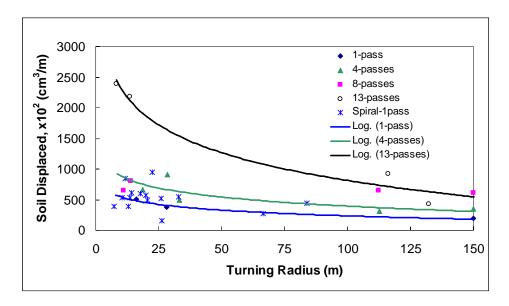
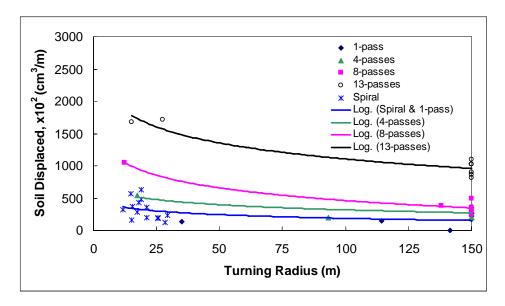
section of the multi-pass section (Fig. 24b). The increase in soil displacement as the turning radius decreases is due to the wider track that is created, since the second, third, and fourth tires do not follow the first tire track.

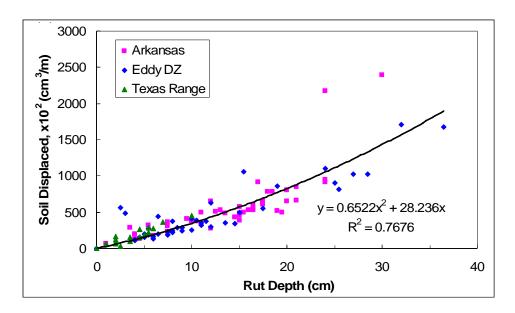
Figure 25. Rut depth versus average volumetric soil displacement at Arkansas Range, Eddy Drop Zone, and Texas Range.

The volume of the soil being displaced by the vehicle was computed based on the enclosed rut area within 1 m of the track length. The volumetric soil displacement is an average of the volume of soil displaced for left and right wheel paths. This analysis was calculated only for the Stryker data at DTA because these were the only data with comprehensive photos of rut depth from the profilometer measurements.

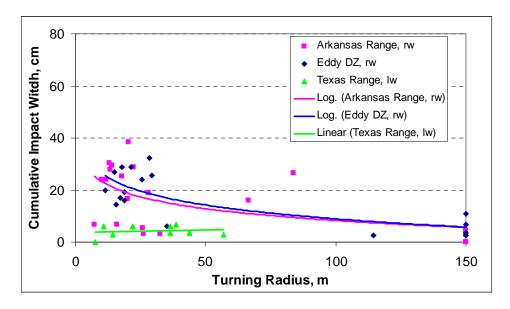
Figure 26. Stryker vehicle turning radius and cumulative impact width relationships for the outside tracks for Alaska sites (single pass and spiral only). Arkansas Range and Eddy Drop Zone are considered deep thaw; Texas Range has a shallow thaw depth.

The cumulative impact width was calculated only for the spiral and single pass sections of the multi-pass maneuver tests. Because the cumulative impact width accounts for only one tire track, the disturbance used in this analysis is for the outside tire track only (Fig. 26). Texas Range had significantly less cumulative impact width than Arkansas Range and Eddy Drop Zone (Fig. 26). This was attributable to shallow thaw at Texas Range, while Arkansas Range and Eddy Drop Zone had deeper thaw. The cumulative impact width trend for Texas Range appears to have a linear relationship to the turning radius (Fig. 26). In general, the cumulative impact width showed less on straight sections and higher as the vehicle is turning. This is due to the higher force required for the vehicle to turn, and generating larger shearing effect on to the thawed, soft soil.

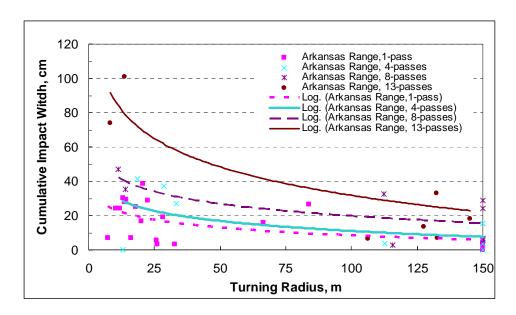
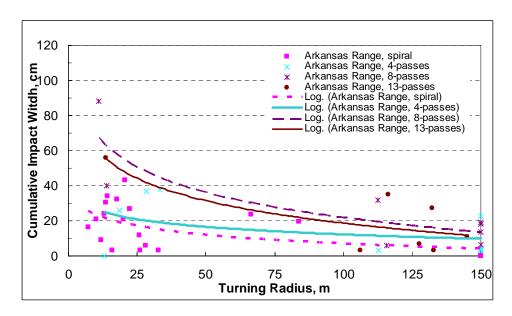
Figure 27. Turning radius and cumulative impact width of single and multipass tests at Arkansas Range.

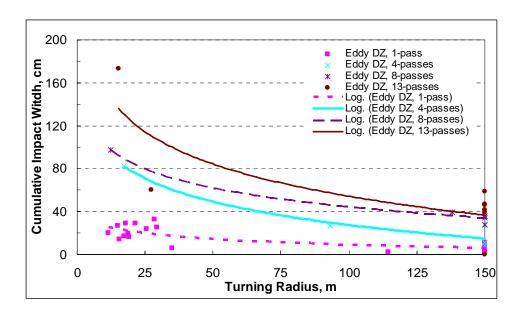
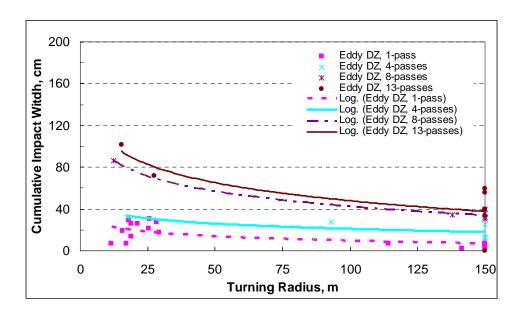
Figure 28. Right and left wheel plots of turning radius versus cumulative impact width for single and multi-pass runs at Eddy Drop Zone.

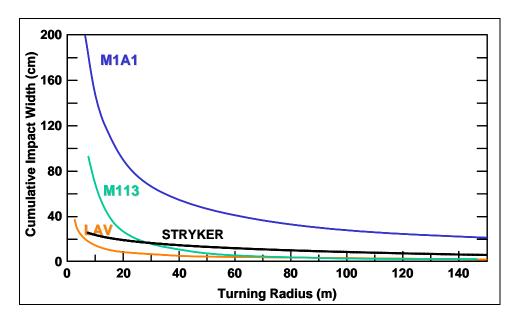
Figure 29. Comparison of cumulative impact width versus turning radius for various military vehicles for single pass. LAV, M113, and M1A1 data were collected from other military lands during the summer season (Ayers et al. 2000, Haugen 2002, Haugen et al. 2002).

The single-pass cumulative impact width and turning radius relationships for other vehicles, such as the LAV, M113, and M1A1, that were derived from various training sites during summer conditions on unfrozen terrain, are used for comparison. Using the relationship from the Arkansas Range data (for the inside wheel track), the Stryker's cumulative impact width on thawing ground showed not as severe at small turning radius compared to the other military vehicles, as seen in Figure 29. The disturbance to the vegetation and soil is greater for the Stryker vehicle on thawed terrain than for the M113, a tracked vehicle on terrain under normal conditions, at turning radius between 40 m and 150 m (straight path).

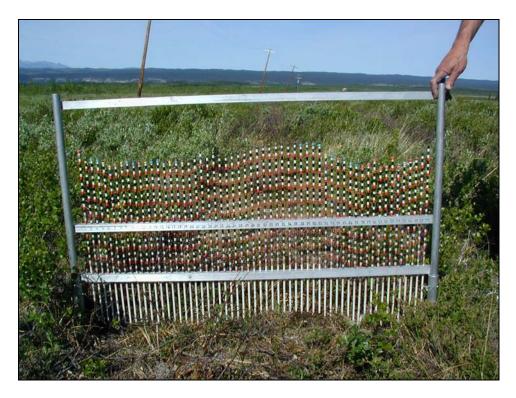
Figure 30. Minor vegetation disturbance and no measurable rut depth resulted from the winter disturbance test.

There were no measurable ruts at both the multi-pass and spiral section during the winter disturbance test. Figure 30 is a rut profile at the thirteen-pass section of the multi-pass section. The impact severity of 10% resulted from the survey showing the track imprint with vegetation roots still intact, laying down of vegetation, and few broken branches.

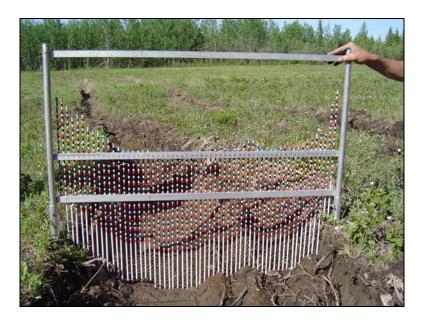
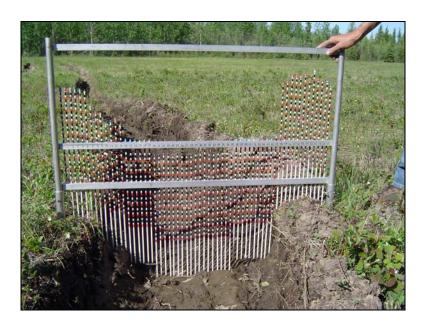
Figure A1. Rut profiles on point A13H on turn section of thirteen-pass at the Arkansas Range.

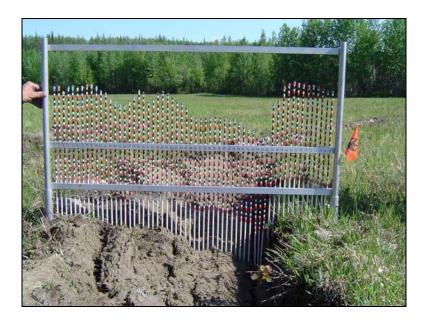
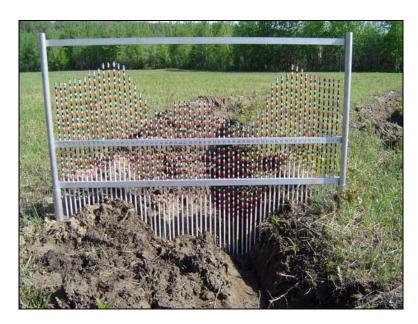
Figure A2. Rut profiles on point A8A on turn section of eight-pass at the Arkansas Range.

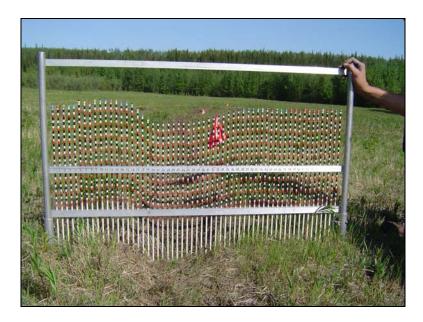
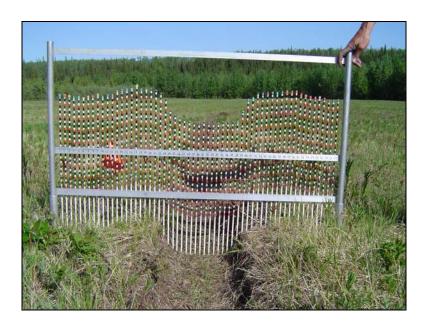
Figure A3. Rut profiles on point A4D on drier section of four-pass at the Arkansas Range.

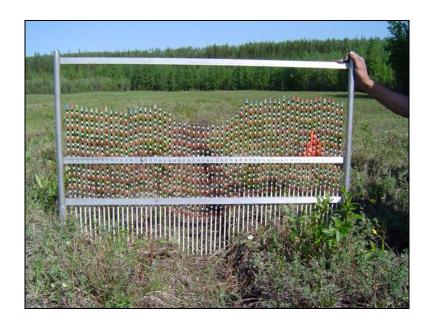
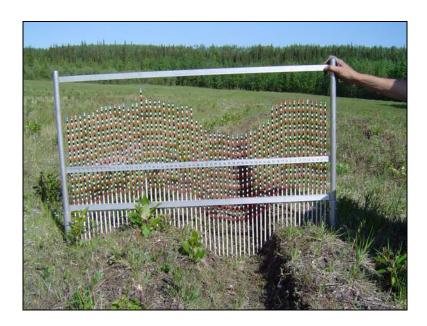
Figure A4. Rut profiles on point A1B on drier section of one-pass at the Arkansas Range.

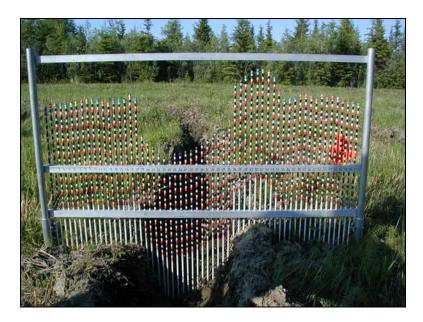
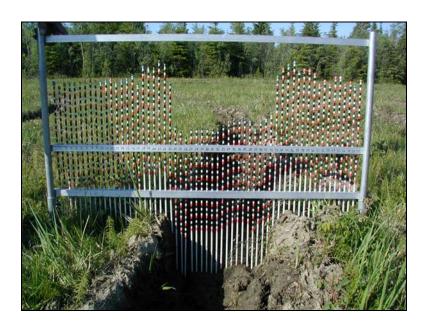
Figure A5. Rut profiles on point AS2B on spiral section at the Arkansas Range.

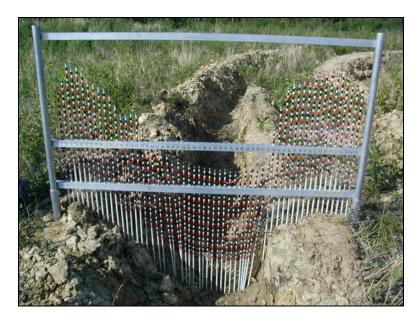
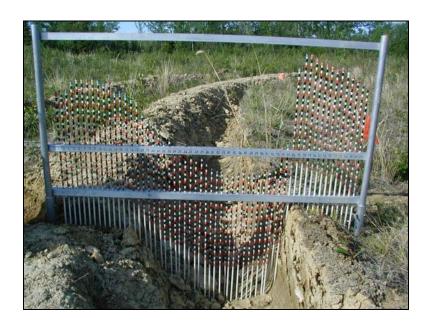
Figure A6. Rut profiles on point E13G on turn section of thirteen-pass at the Eddy Drop Zone.

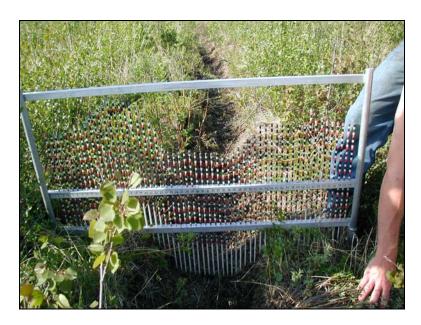
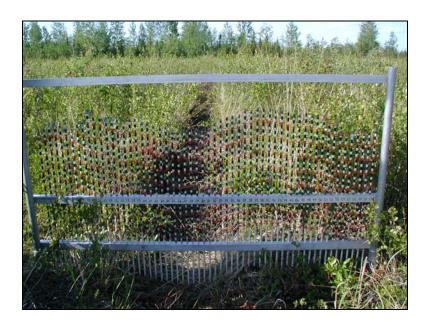
Figure A7. Rut profiles on point E4C on straight section of four-pass at the Eddy Drop Zone.

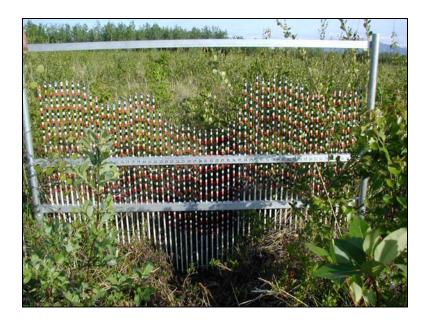
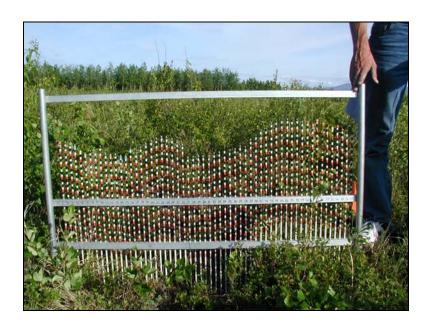
Figure A8. Rut profiles on point ES-2C on spiral section at the Eddy Drop Zone.

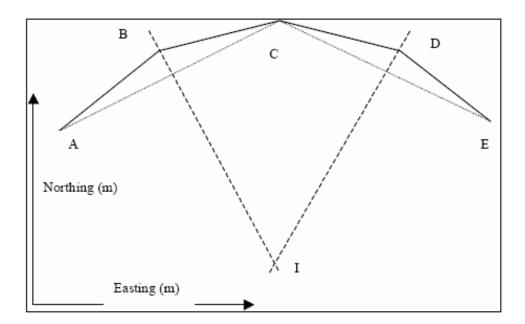
Figure D1. Turning radius.

Turning radius was calculated using five data points with plane geometry referencing the northing and easting of each point. The equations used to calculate the turning radius for the points are illustrated in Figure D1. Perpendicular bisects to lines connecting the first to the third, and third to the fifth, data points were calculated from the coordinates of those points. The intersection of those two perpendicular bisects was determined by solving two equations with two unknowns. Turning radii greater than and equal to 150 m are assigned a value of 150 m, and are considered as straight path.
